DAMAGE ASSESSMENT OF ANNAPURNA REGION NEPAL - JULY 15, 2015

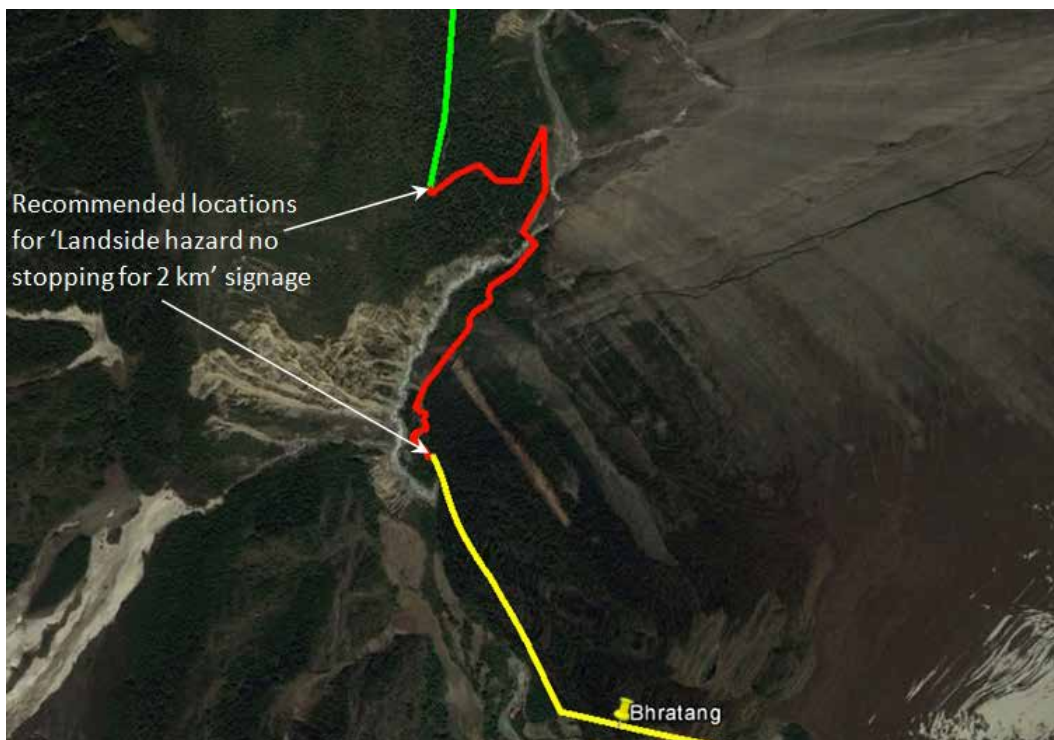
- We recommend placing 'Landslide Hazard No Stopping for 2 km' signage on either side of the new regolith landslide north of Bhratang. The location of the high-hazard area, as shown in the photograph below, extends from the hairpin turns in the track south of the landslide to the hairpin turn at the top of the hill on the north side of the river – where the track turns north again. This area should be considered to have a heightened chance of future landslide failure and people should be encouraged to walk through the area without stopping to reduce the track occupancy time in the area.

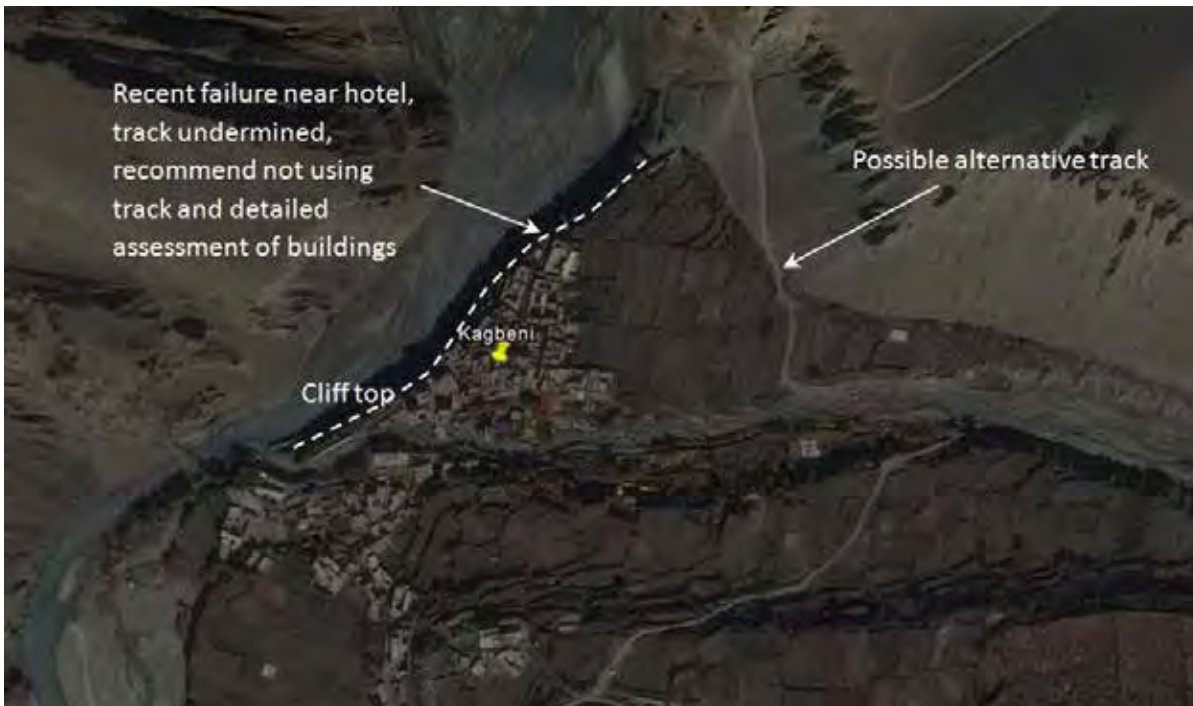
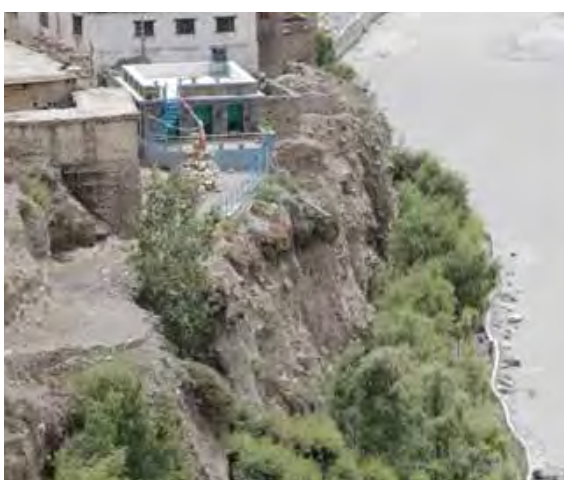
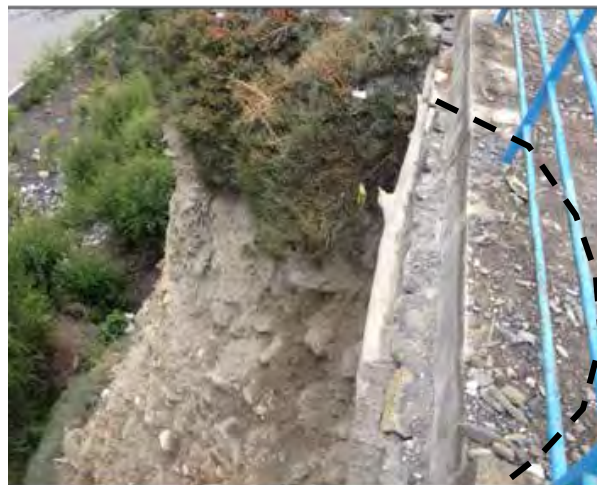
- We recommend a detailed assessment of the gravel cliff stability on the north side of Kagbeni as it may affect the buildings near the crest. There is one building we understand to be a hotel (there may be more) located at or very near the cliff edge. Given the apparent cliff instability, we consider the risk of using this building may be unacceptably high in its current state. The adjacent area around the blue handrail is also considered to be at high risk of failure as it is already undermined. While this track is not strictly part of the Annapurna Circuit track, we recommend another route is used.

Recent failure near hotel, track undermined (not Annapurna Circuit) Track undermined, no support at edge

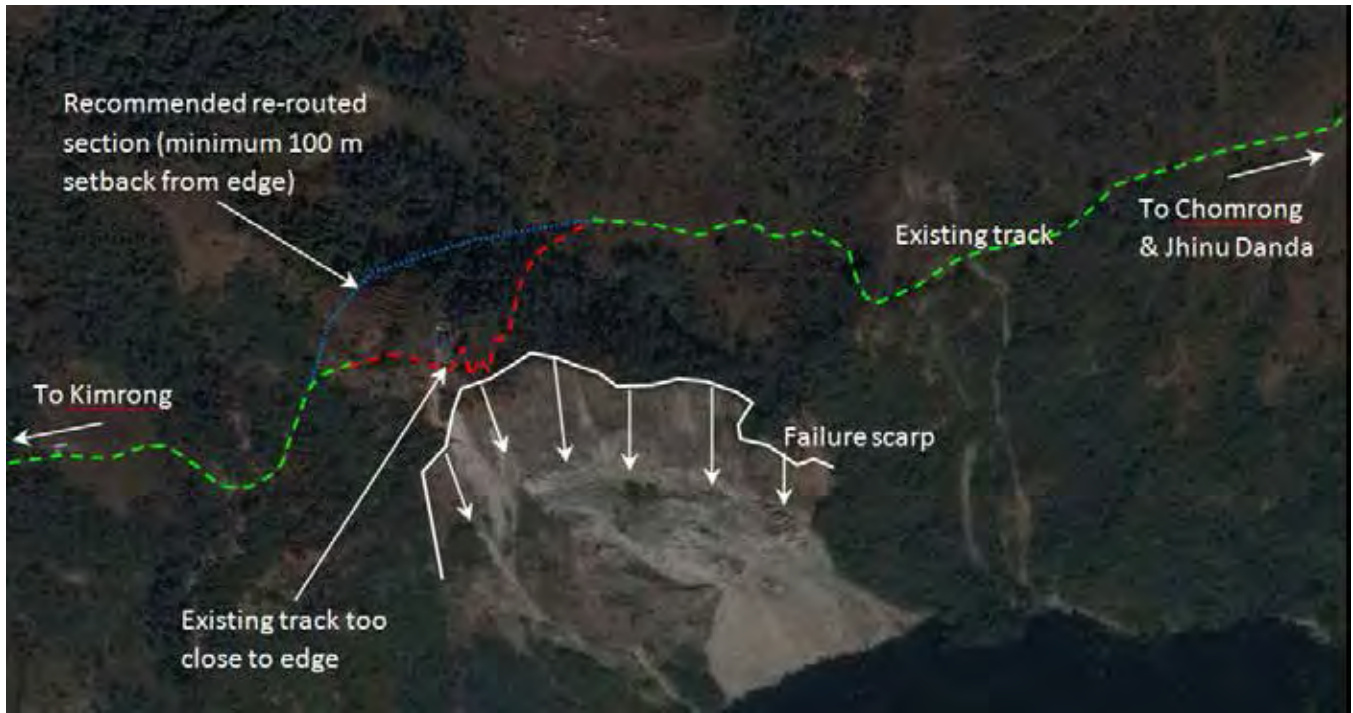
- We recommend re-routing the section of track that is located at the scarp of the large rockslide between Kimrong and Chomrong / Jhinu Danda (southern part of Annapurna Sanctuary tracks). The track is located within 2 m from the edge of the failure and a building is within approximately 20 m of the edge. The track should be located at least 100 m upslope from the edge of the failure. The section of track that requires re-routing is approximately 250 m long and can tie back into the existing trail where it is located further back from the failure. Warning signage should be placed on the track near the edge of the failure indicating 'Danger cliffs and landslide hazard' or similar so it is clear to use the new section of track. We recommend that the building in close proximity to the headscarp is assessed in detail to determine the level of landslide risk to any occupants.

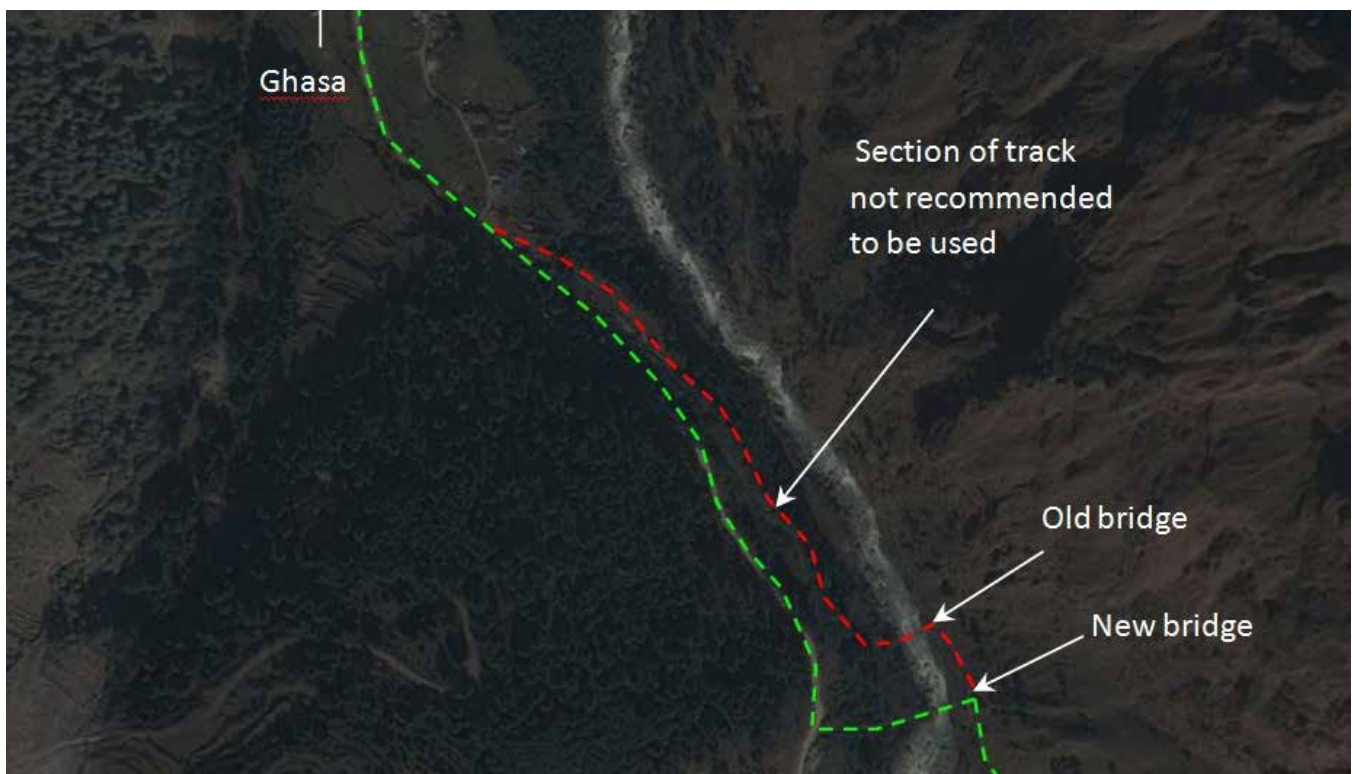
- We recommend the older section of trail south of Ghasa that leads to the old foot bridge (bridge nearest Ghasa) be abandoned in favor of the road located further west that leads to the newer bridge as discussed in previous sections. Signage should be placed on the track to the old bridge indicating there is a landslide hazard.
