DAMAGE ASSESSMENT OF ANNAPURNA REGION NEPAL - JULY 15, 2015

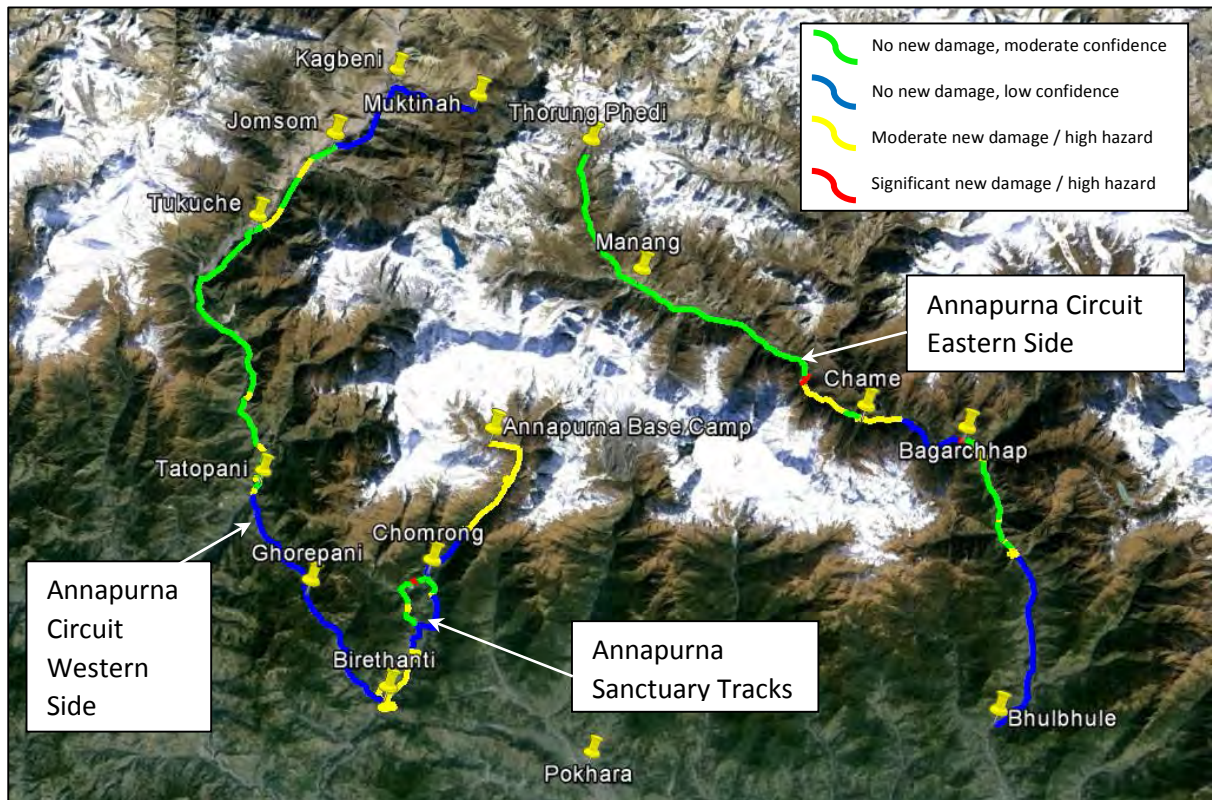
Figure 2: Trekking Route Location Plan

We have mapped areas of observed damage, areas of no observed damage and areas of high or heightened hazard over a Google Earth satellite image. The track areas we assessed are coloured to show observations as follows:

Green Areas of no observed new damage, moderate confidence of observations

Blue Areas of no observed new damage, low confidence of observations

Yellow Areas of moderate observed new damage and/or high level of existing hazard

Red Areas of significant observed new damage and/or high level of existing hazard

The Thorung La Pass between Thorung Phedi and Muktinah was not covered due to weather constraints. This section involves a high mountain pass and is likely to have a very significant level of landslide and avalanche hazard. However, we expect that the natural hazards in this area have not significantly increased as a result of the earthquake.

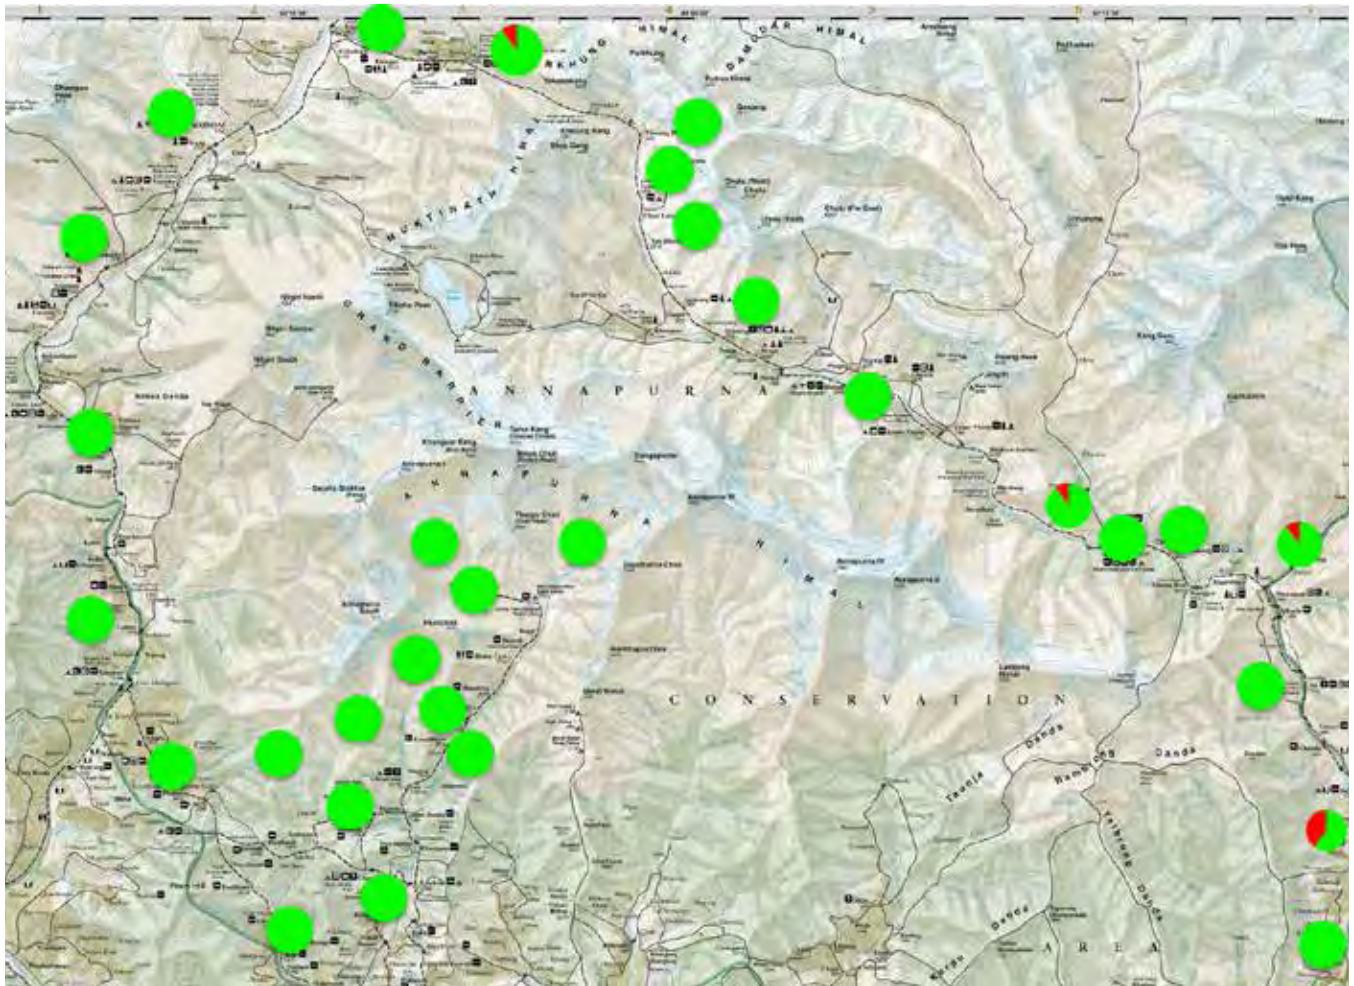
Figure 1. ABOVE - The green marks the percentage of undamaged structures and the red marks the percentage of earthquake-damaged buildings in the 15 villages that were assessed following the April and May 2015 earthquakes.
